# SCOTFORD GOAL ZERO WEEKLY AND TURNAROUND TIMES

## MONDAY, APRIL 24, 2023

# Go & Engage – Hydrocarbon Release from Thermocouple Installation

Hydrocarbon Release from Thermocouple Installation, CP-AW-202302

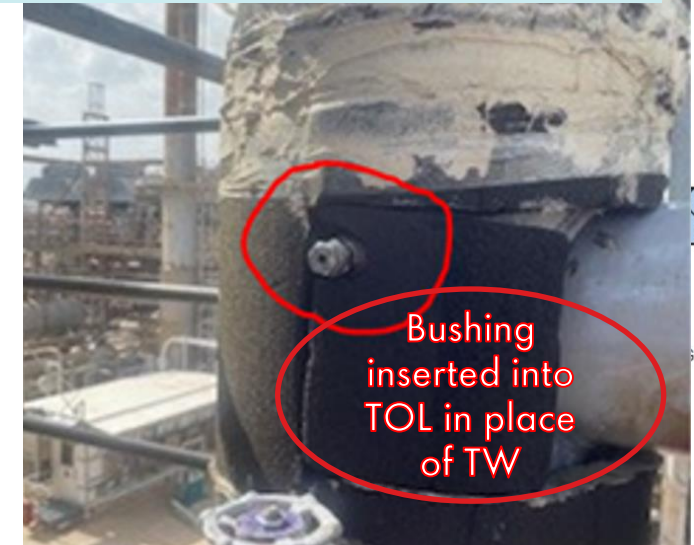
**Distran – Ultra Sonic Camera**

- The system was pressurized to about 550 PSIG during start up.
- An area operator's personal gas monitor detected a leak near the overhead line, and the leak was found to be from the TE using an ultrasonic leak detecting camera.
